Report on  
Land Capability Assessment

Site 5 - Wallarah Rezoning  
380 Motorway Link, Wallarah

Prepared for  
Darkinjung Local Aboriginal Land Council

Project 83145.01  
November 2017

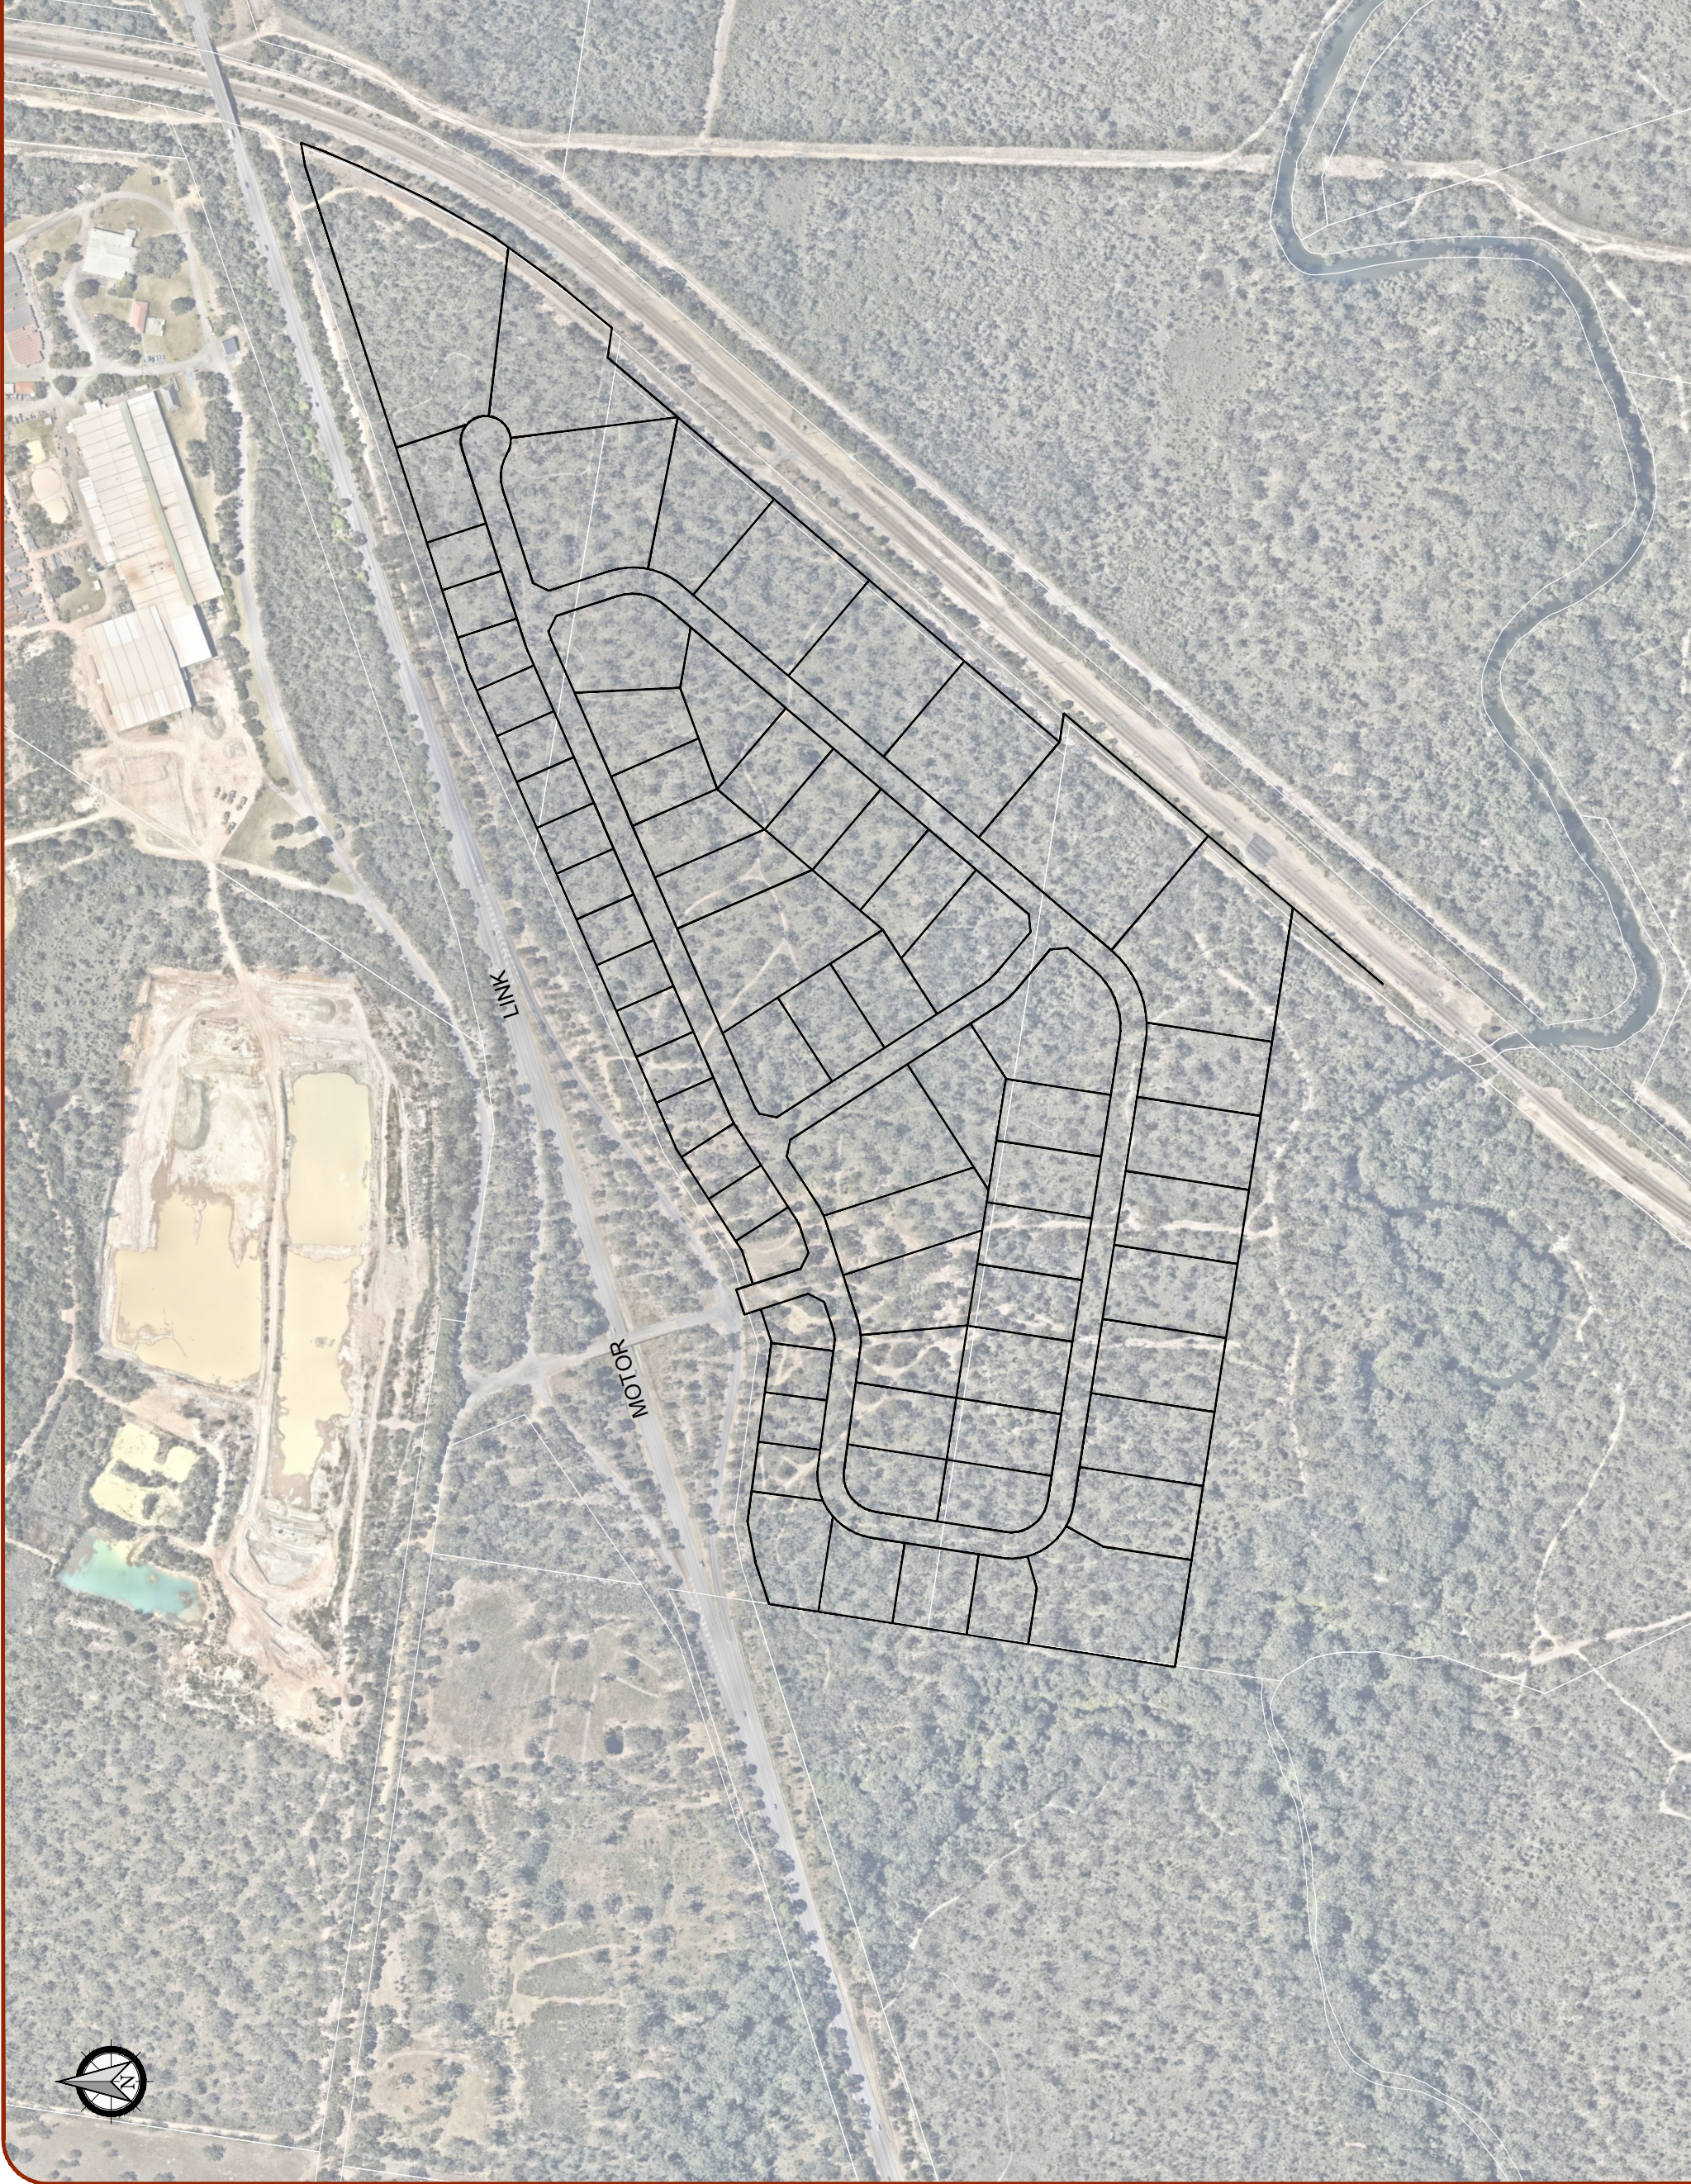
WALLARAH INDICATIVE  
SUBDIVISION LAYOUT
